Final Report of Septic System Survey for Otter Lake Sustainable Lake Plan

March 2018

Karl Fiander, Otter Lake Landowners Association

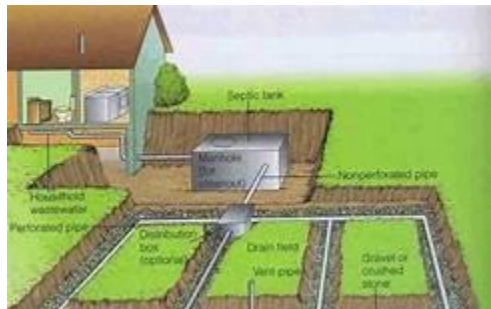
Schematic of a typical septic tank and leaching bed (class 4) system

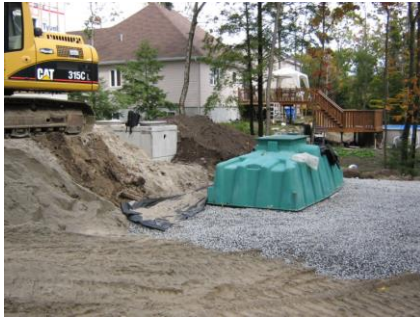
Ecoflo advanced septic treatment system

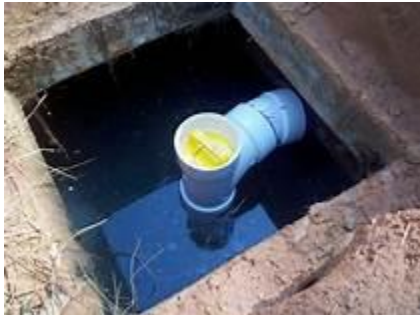
Effluent filter retrofitted to an existing concrete septic tank

2. If your system is fairly old, retrofit an inexpensive cleanable effluent filter on the discharge end of the septic tank. This prevents tank solids from reaching the leaching bed and this extends the life and performance of the bed. These filters are included in new systems but if your system is more than 10 years old it probably was not fitted. They are designed to be hosed off once a year and can be accessed easily through the second access hole in the tank. DIY home-owners can easily install them or you can engage a registered installer.

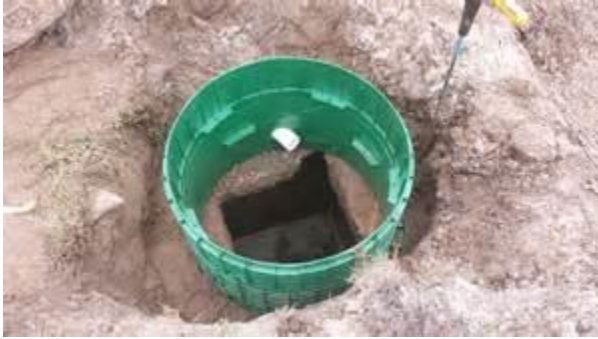
Installation of a plastic riser on an existing septic tank

1. If you can't remember when your septic tank was last pumped, have it cleaned out and inspected. Your pumping service can advise if there are roots, major cracks in the tank or severe deterioration of the concrete. If so these need to be fixed before using the system again. You can consider installing 'risers' over the tank access holes to make it easier to find the holes for an annual inspection. These are available at the Septic Store in Portland or some pump-out service providers can install them.
